LEARNING FROM INCIDENTS

AWARENESS ALERT

2014AW05

Fatalities during a Leak Repair Clamp Re-injection

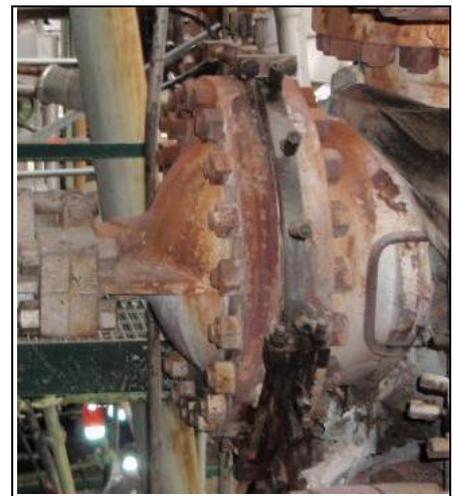
Figure 1 – Similar Valve with bonnet clamp
